# Manhole Inspection Summary

Manhole # **S39KK\_034MH**

Insp Date: **1/18/08 10:26 AM**

**Location** Address: **1814 HOPE ST**

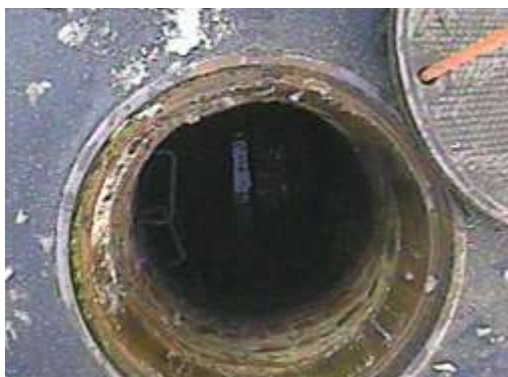
Defect 1

**Steps** Count: **6** Missing: **0** ☒ **Corroded**

corroded steps

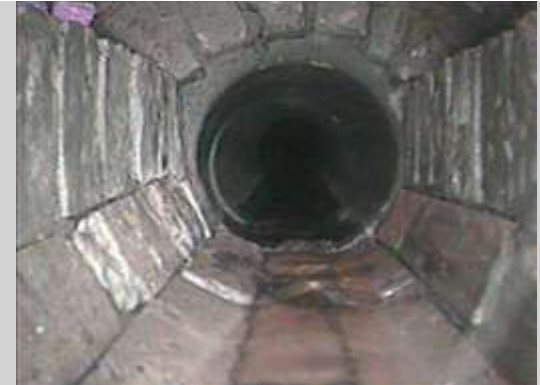
12 O'Clock Outflow

8 in. Circular Gravity Sewer  
Pipe Out @ 12 O'Clock

Pipe Material: **Clay** ☐ Pipe Lined

Invert Depth: **10.70** (ft.) Flow Characteristics: **Slow**

Deposits: ☒ None ☐ Mud ☐ Sludge ☐ Debris ☐ Grease

Infiltration: **None** Pipe Seal Cond: **Sound**

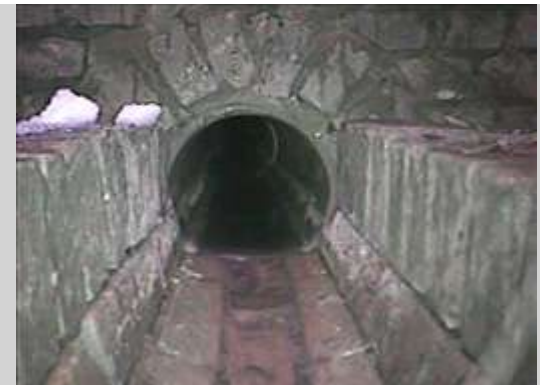
6 O'Clock Inflow

8 in. Circular Gravity Sewer  
Pipe In @ 6 O'Clock

Pipe Material: **Clay** ☐ Pipe Lined

Invert Depth: **10.72** (ft.) Flow Characteristics: **Slow**

Deposits: ☒ None ☐ Mud ☐ Sludge ☐ Debris ☐ Grease

Infiltration: **None** Pipe Seal Cond: **Sound**
